SILVER CREEK STREAM IMPROVEMENT

A PROGRESS REPORT ON PROJECT
F-16-D
FOR 1955-56

BY
Robert B. Irving
Fisheries Biologist

STATE OF IDAHO
DEPARTMENT OF FISH AND GAME
Boise, Idaho
December 31, 1956

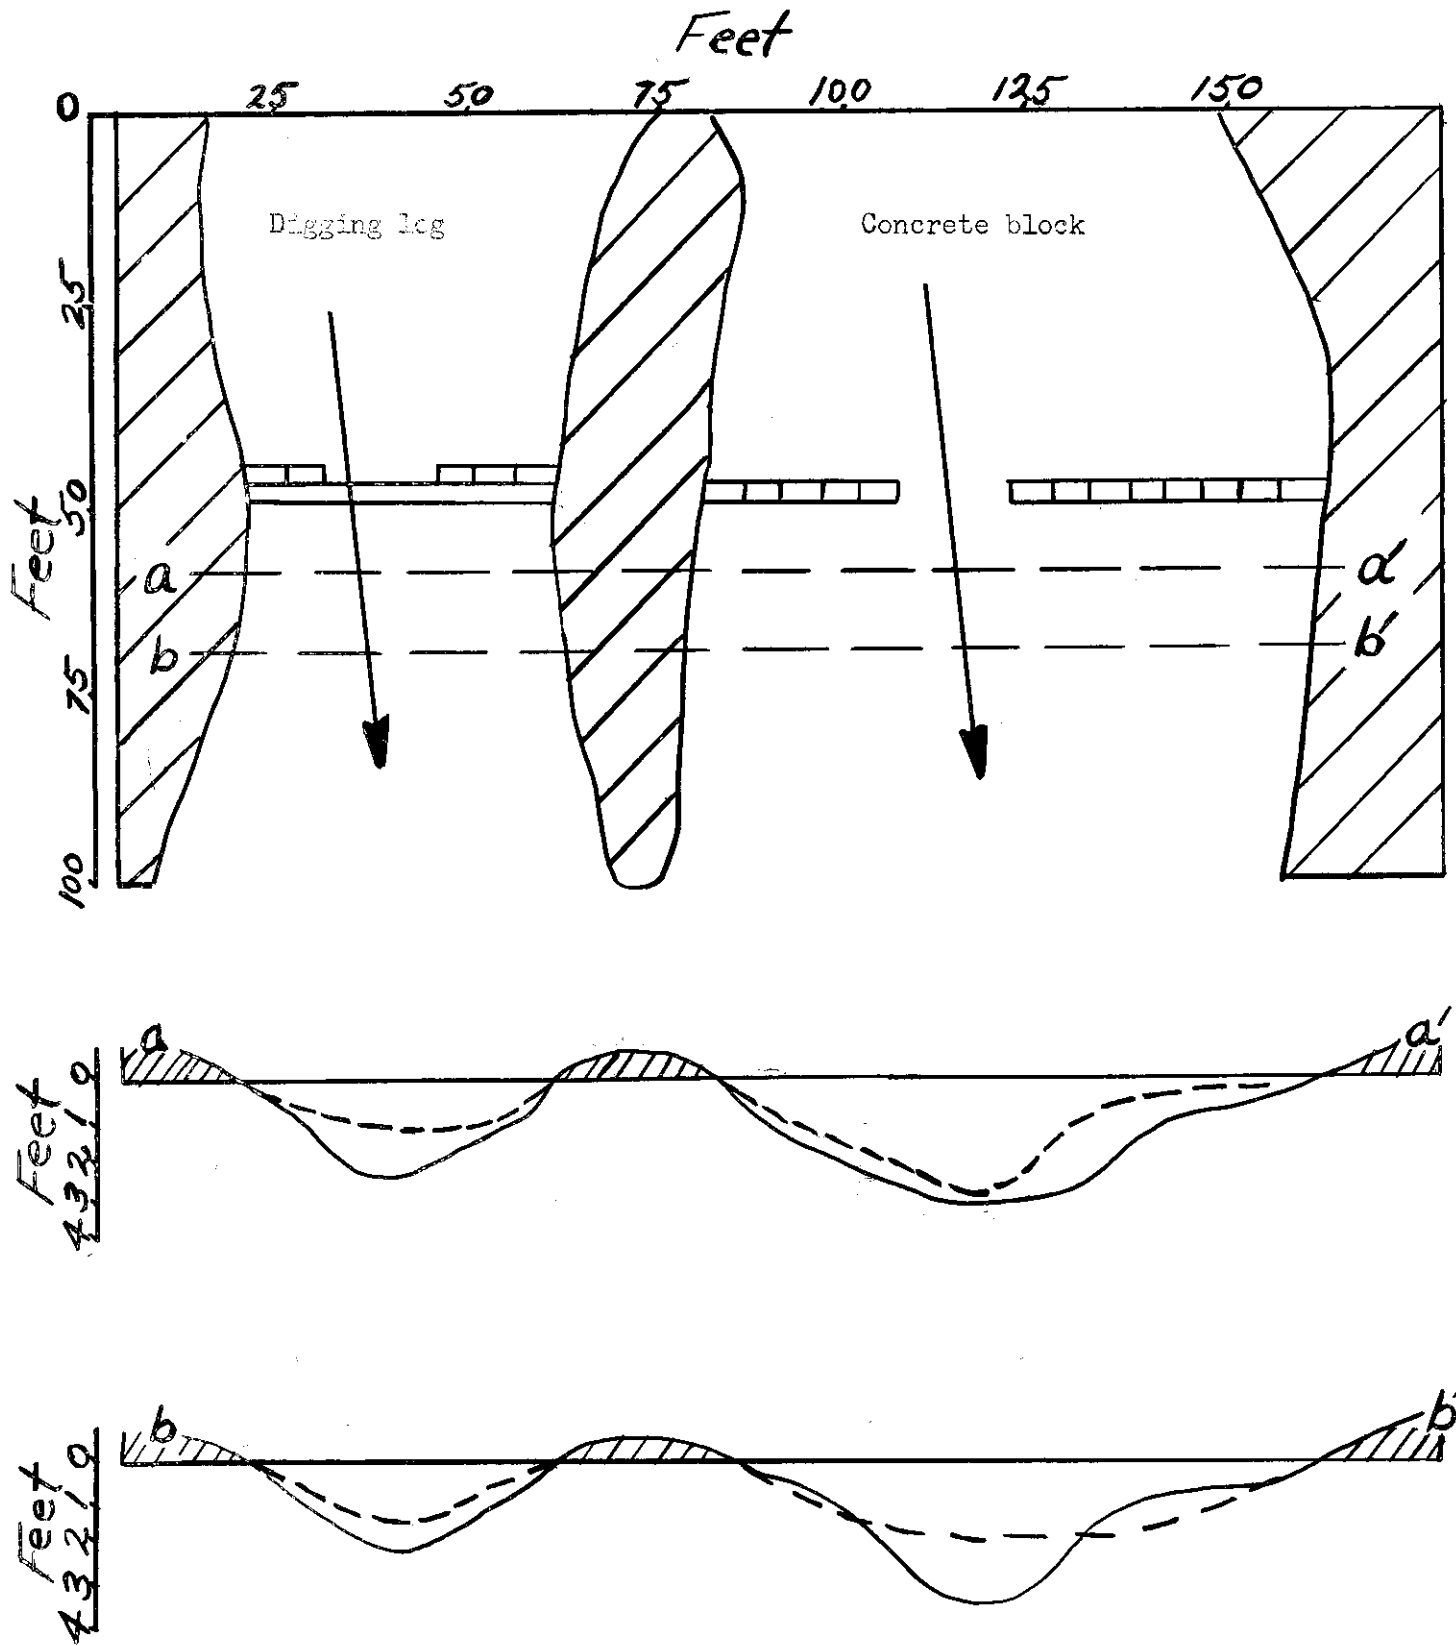
Figure 2. Grove Creek installation #1. Dotted lines show cross-section of stream bottom prior to installation of structures in October, 1955 and solid lines show cross-section of stream bottom in November, 1956.

After the log was placed in the west channel, it appeared that little digging action would occur; therefore, several concrete blocks were placed on the upstream face of the log to farther constrict the flow and increase the digging action. By November, 1956, as a result of a raise in water levels plus digging action, the pool below the digging log structure had increased in depth from 12 inches to 30 inches. (Figure 2).

Within a week after the concrete-block structure had been installed at Grove Creek #1, a large hole had washed under the center blocks of the structure (Plate 2). Corrective action was taken by removing the base and common blocks above the hole and adding common blocks on either side to restrict the flow to the open section in the center of the stream. By November, 1956, as a result of a raise in water levels plus digging action, the pool below the structure had enlarged and increased in depth from 30 to 42 inches (Figure 2).

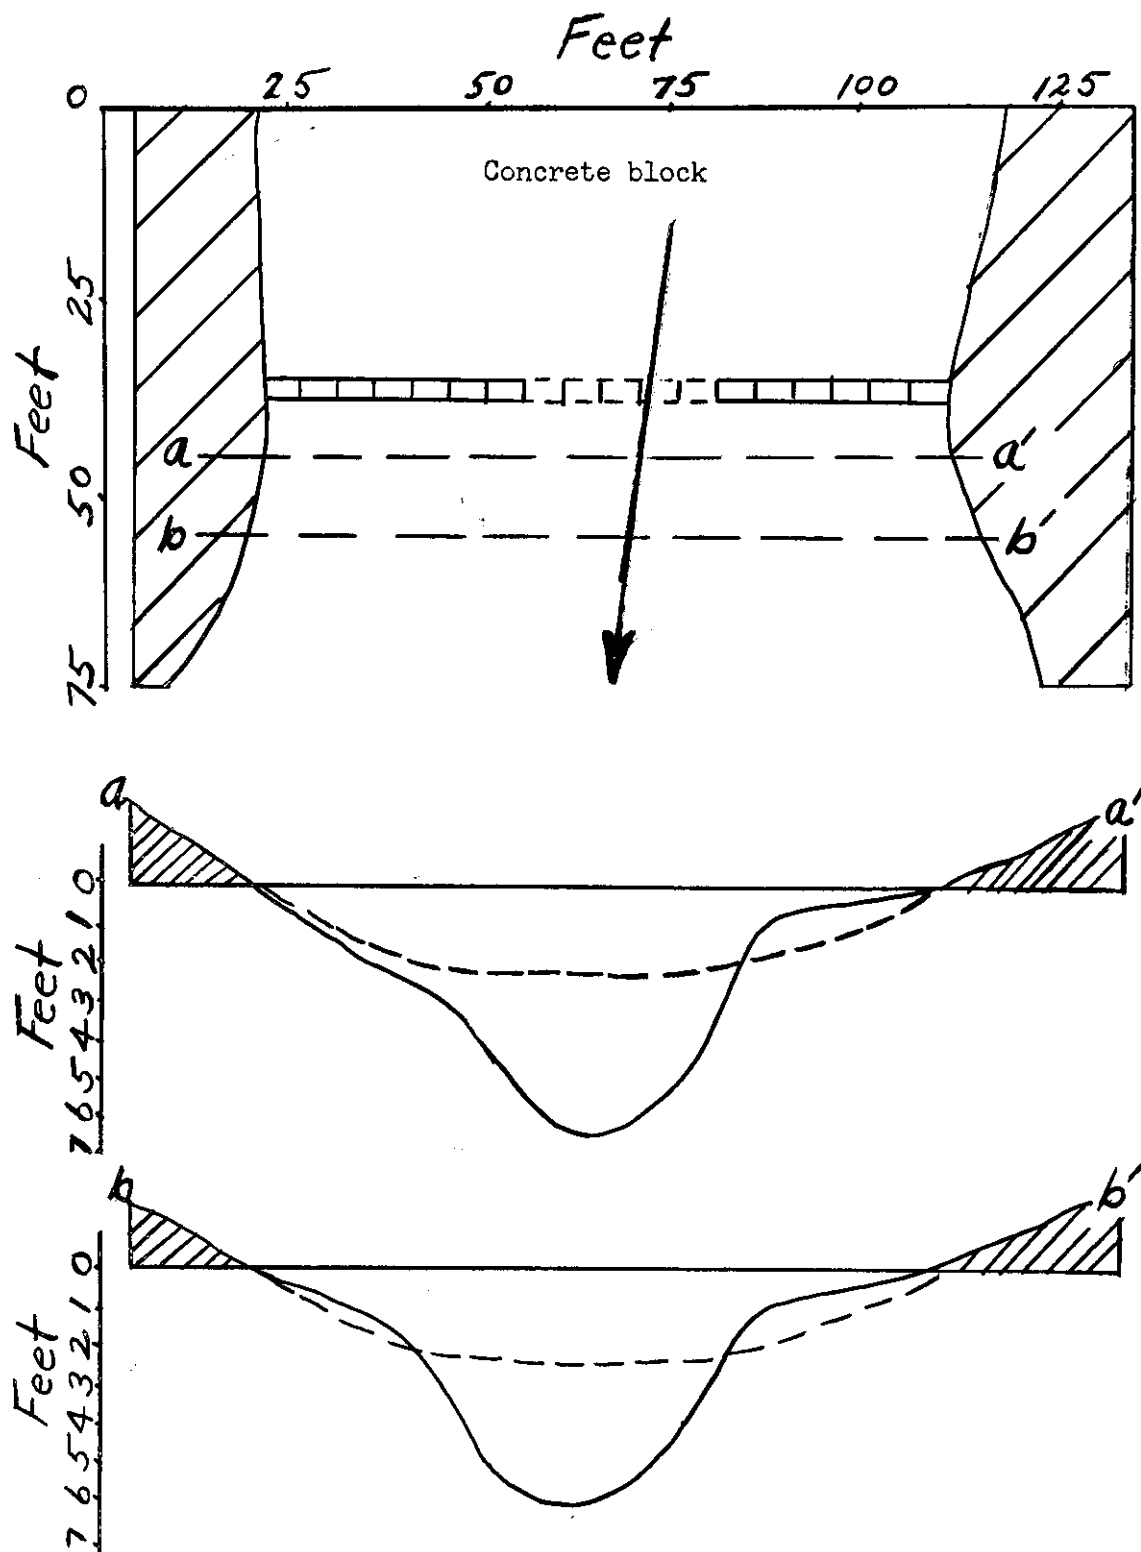
Figure 3. Grove Creek installation #2. Dotted lines show cross-section of stream bottom prior to installation of structure in October, 1956 and solid lines show cross-section of stream bottom in November, 1956.

Grove Creek installation #2. A concrete-block structure was installed at this site in October, 1956. Digging action began immediately, in fact, several loads of gravel and boulders were placed on the upstream side of the structure to prevent it from washing out before it could be completed. Within two weeks, the pool below the structure had enlarged and increased in depth from 25 inches to 74 inches. (Figure 3).

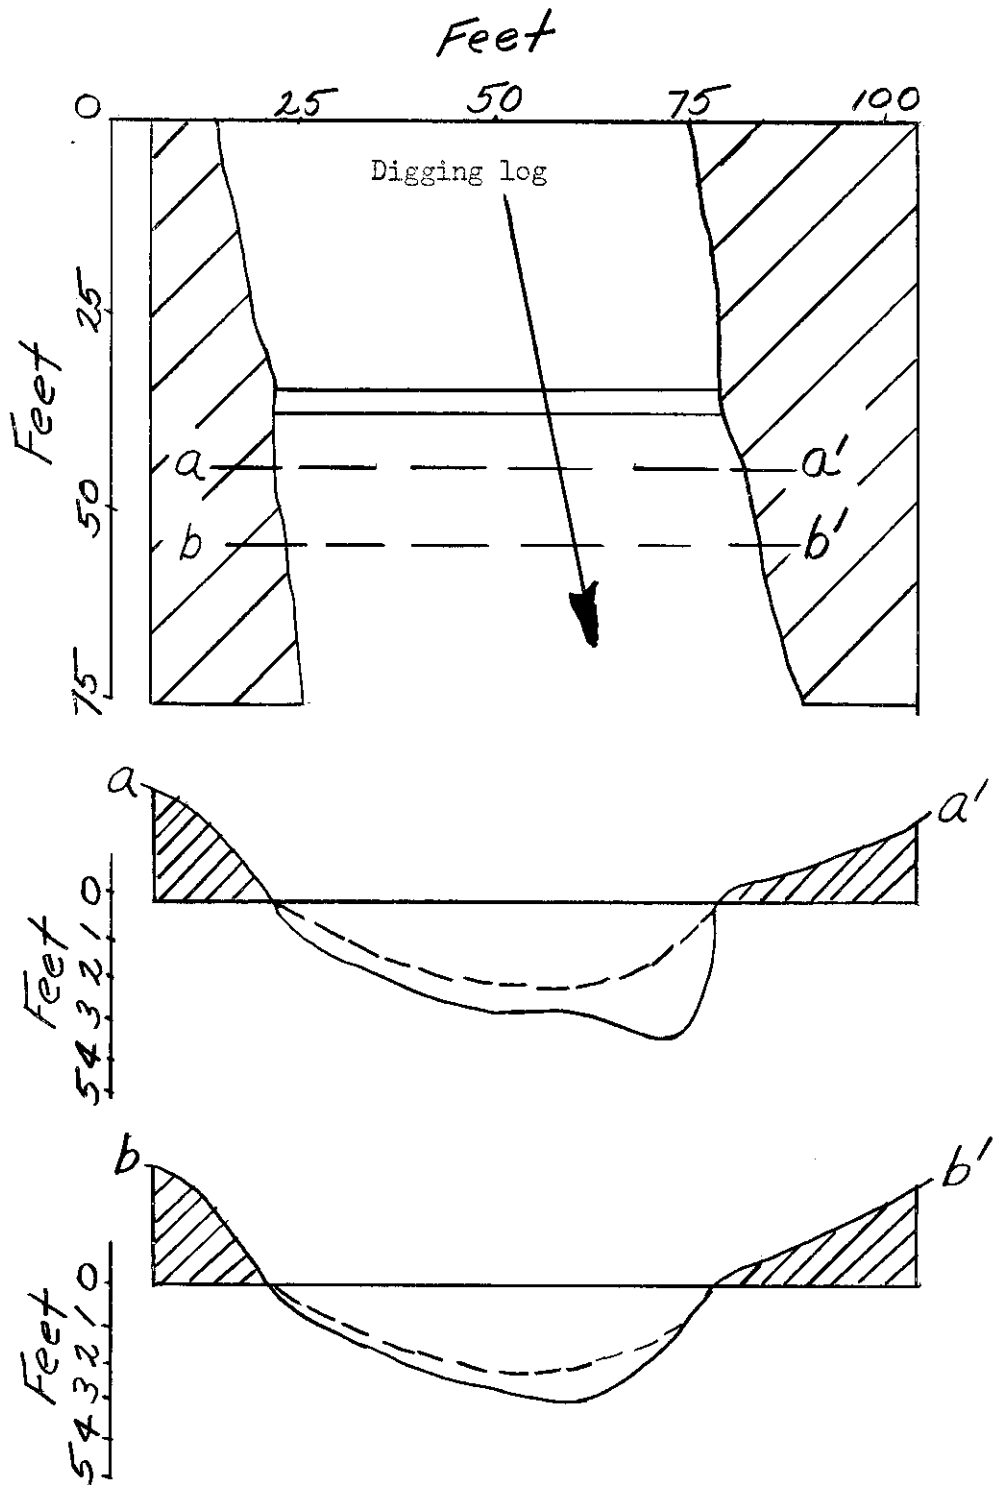
Figure 4. Grove Creek installation #3. Dotted lines show cross-section of stream prior to installation of structure in October, 1955 and solid lines show cross-section of stream bottom in November, 1956.

Grove Creek installation . A digging log structure was installed at this site in October, 1955. By November, 1956, as a result of digging action, the pool below the structure had enlarged and increased in depth from 25 inches to 38 inches (Plate 4, and Figure 4).

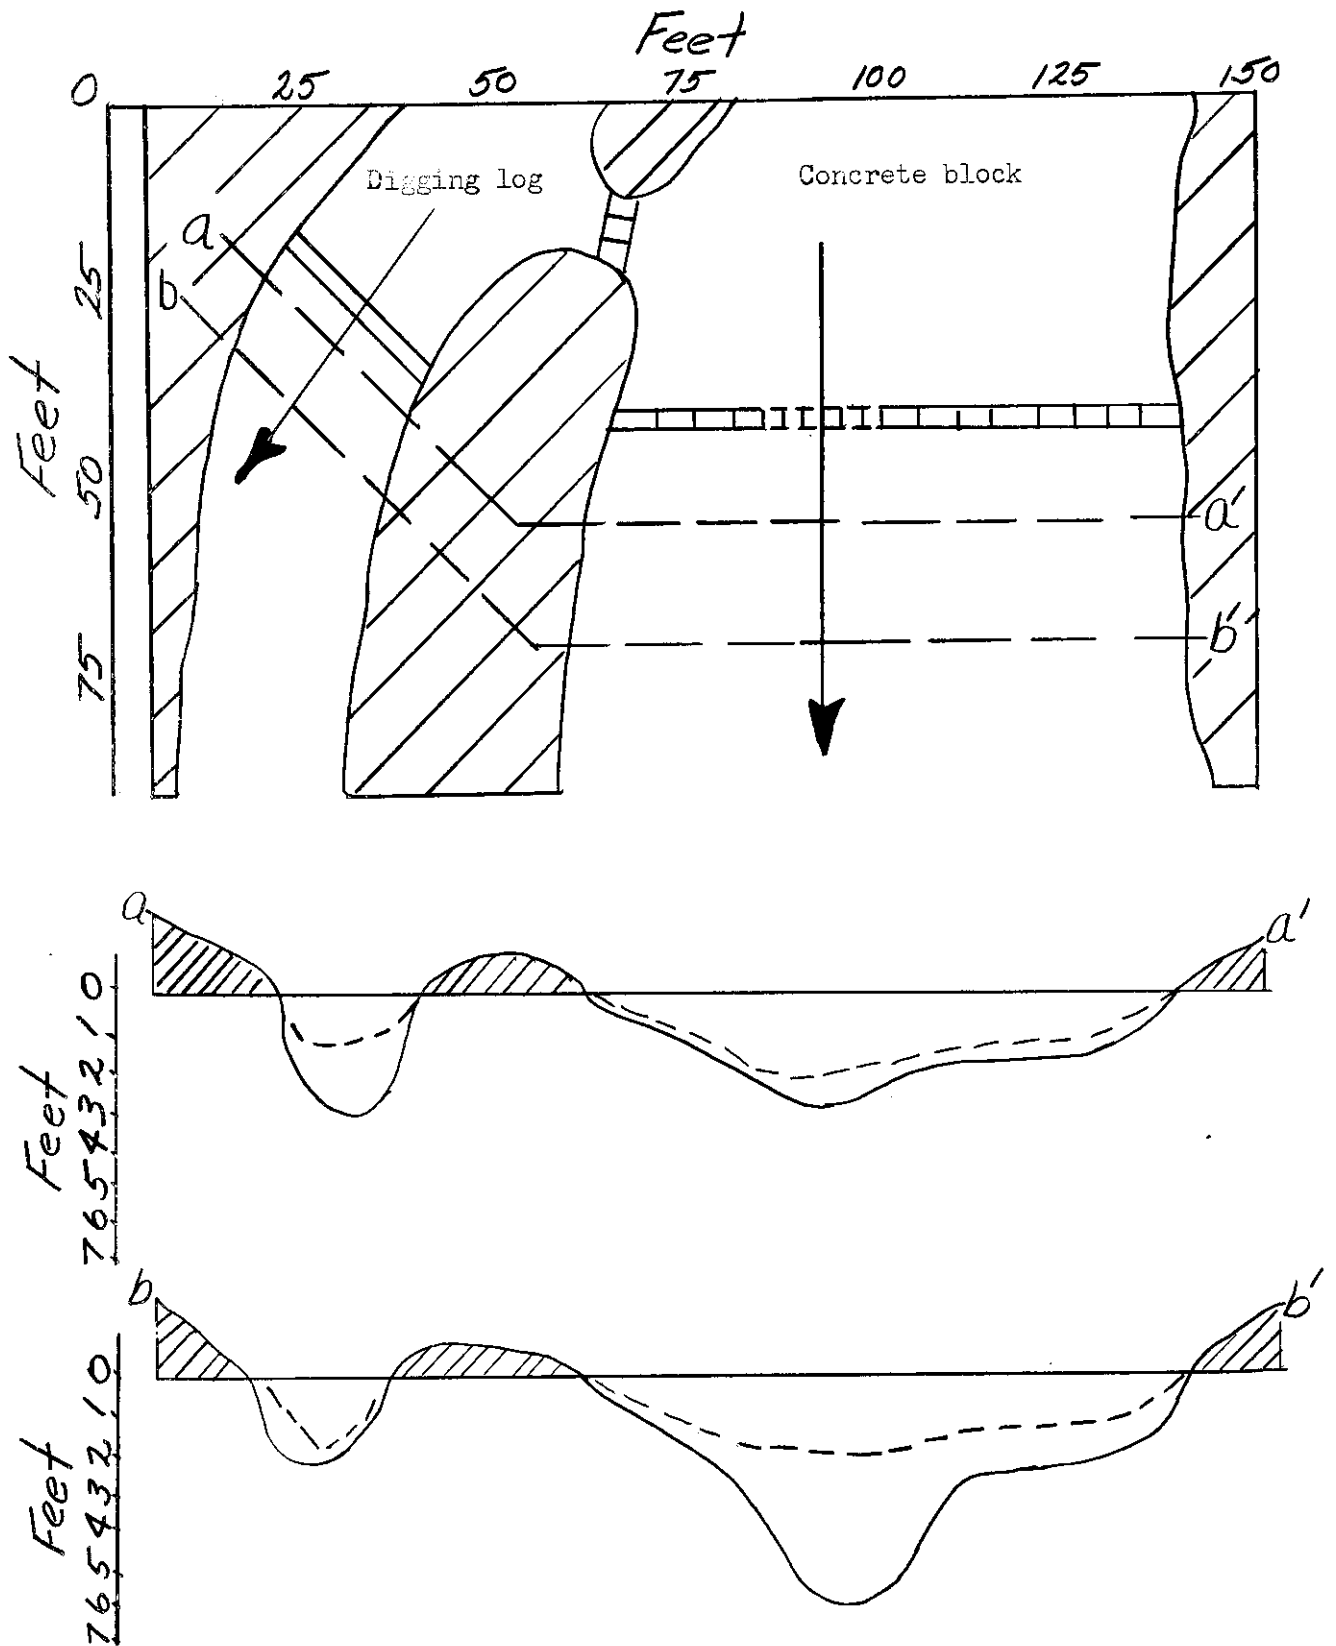
Figure 5. Grove Creek installation #4. Dotted lines show cross-section of stream bottom prior to installation of digging log and concrete block structures in October, 1955. Solid lines show cross-section of stream bottom in November, 1956.

By November, 1956, the pool below the digging-log structure, as a result of a raise in water levels plus digging action, had enlarged and increased in depth from 20 to 39 inches (Figure 5).

After the concrete-block structure was installed at this site in October, 1955, several loads of gravel were placed along the upstream face of the base blocks to prevent washing beneath the structure. Within a week after this structure had been completed; the pool below had deepened to 50 inches and by November, 1956, as a result of a raise in water levels plus digging action, the pool was much enlarged and had increased in depth from the original 29 inches to 72 inches (Figure 5).

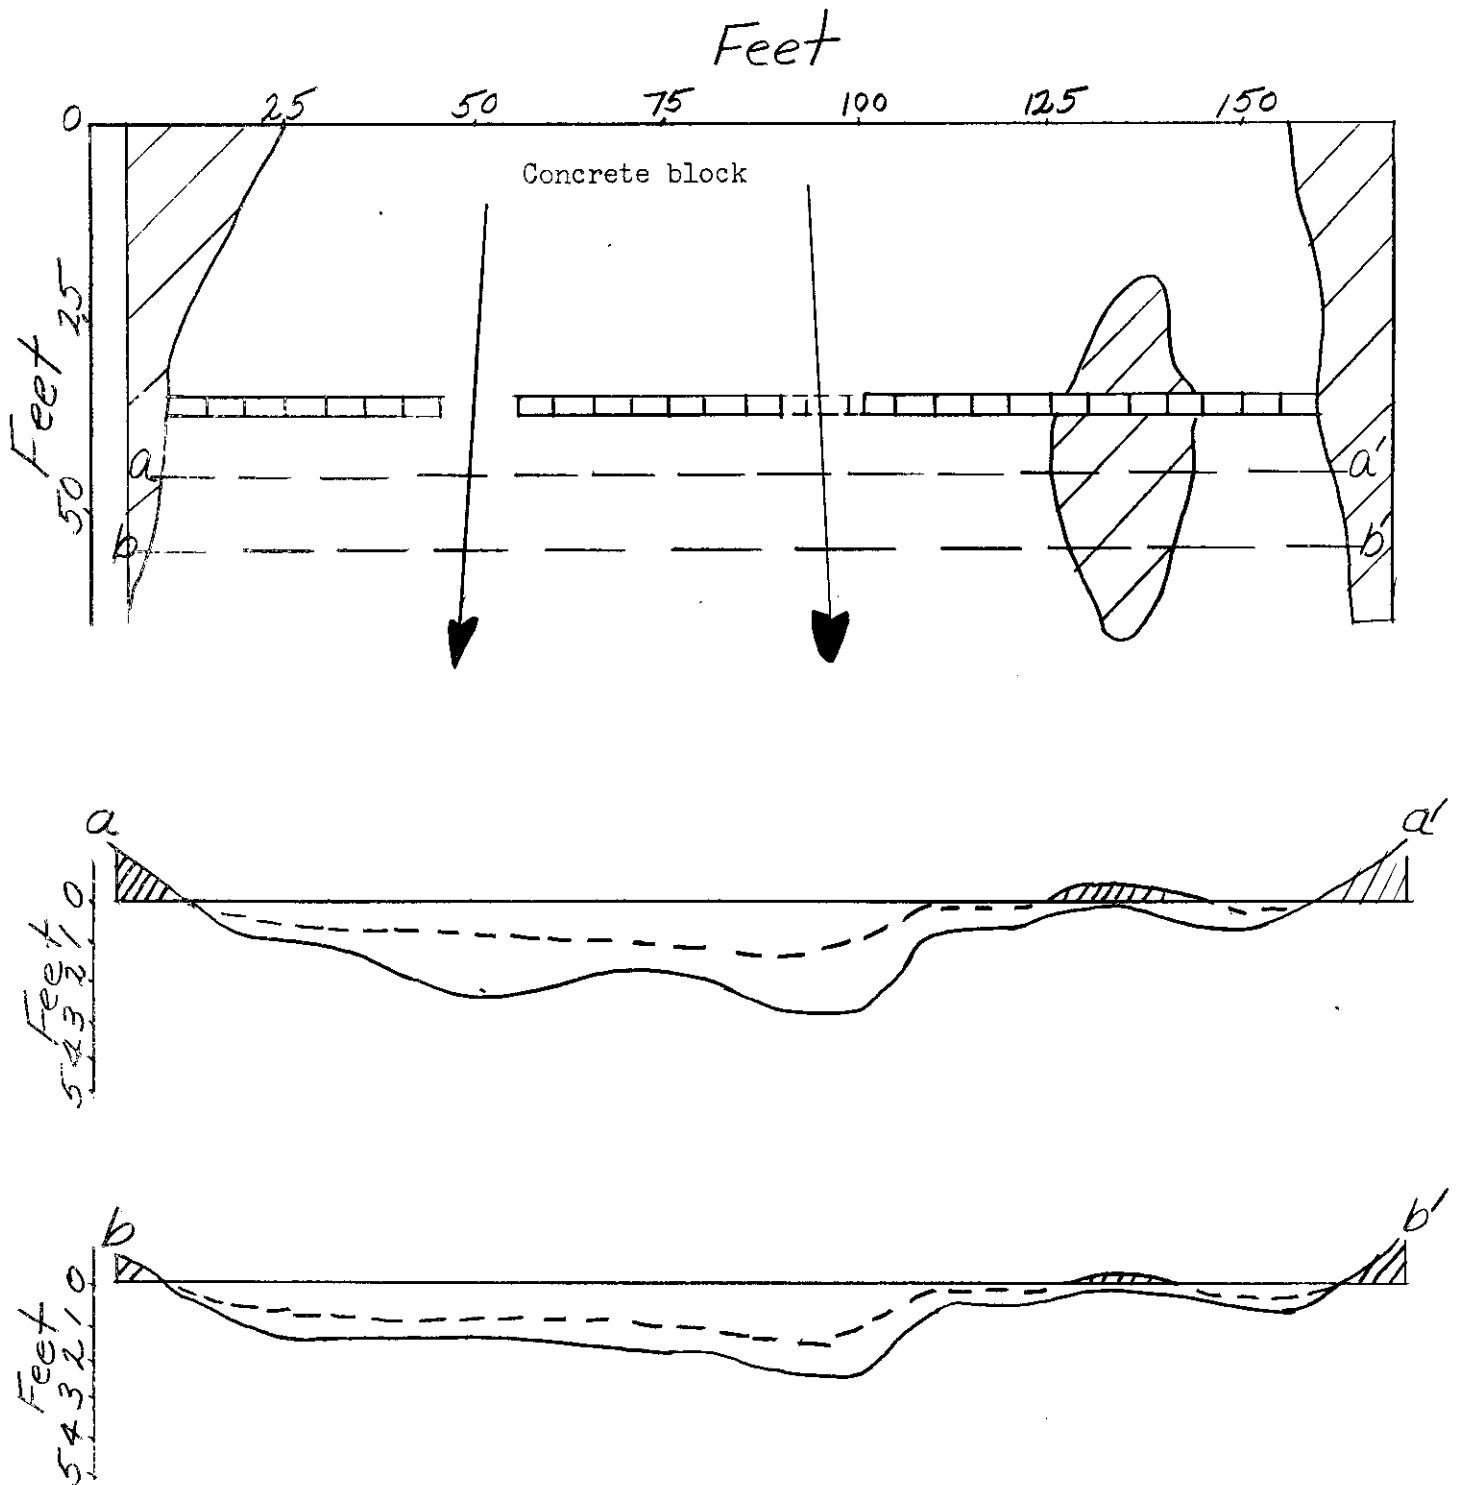
Figure 6. Grove Creek installation #5. Dotted lines show cross-section of stream bottom prior to installation of concrete-block structure in October, 1955. Solid lines show cross-section of stream bottom in November, 1956.

Grove Creek installation . The concrete-block structure installed at this site in October, 1955 is 150 feet in length: Grove Creek proper is 100 feet in width and the low bank on the east side is 50 feet in width. By May of 1956, a large hole had washed under the base blocks in the channel opening on the west side of the structure. The base blocks and common blocks above this hole were removed and additional common blocks were placed on the structure to restrict the flow to the two openings. By November, 1956, the pools below the west and east openings in the structure, as a result of a raise in water levels plus digging action, had enlarged and increased in depth from 12 to 30 inches and 17 to 36 inches, respectively (Figure 6).

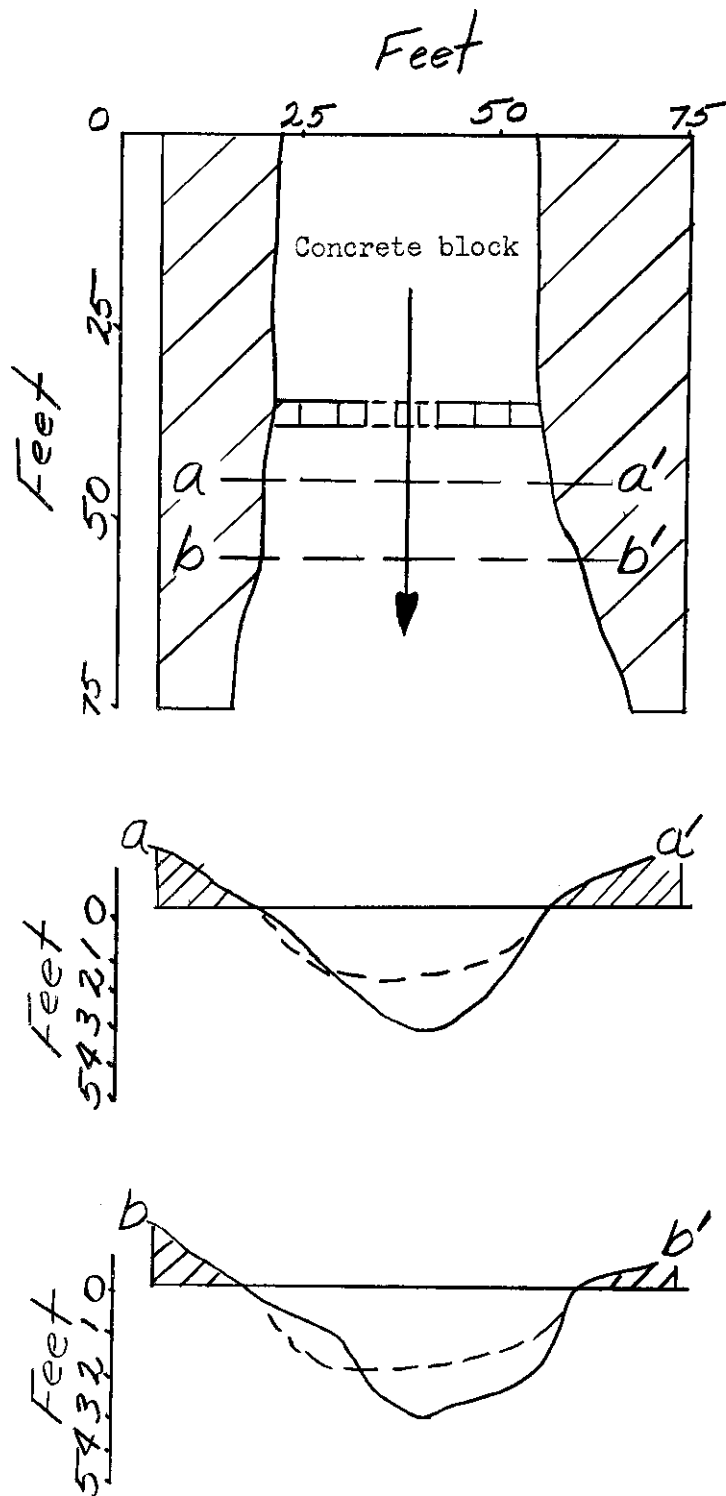
Figure 7. Loving Creek installation #1. Dotted lines show cross-section of stream bottom prior to installation of concrete-block structure in October, 1956. Solid lines show cross-section of stream bottom in November, 1956.

Loving Creek installation #1. A concrete-block structure was installed at this site in October 1956. By November, 1956, the pool below the structure, as a result of digging action, had enlarged and increased in depth from 24 to 37 inches (Plate 38 and Figure 7).

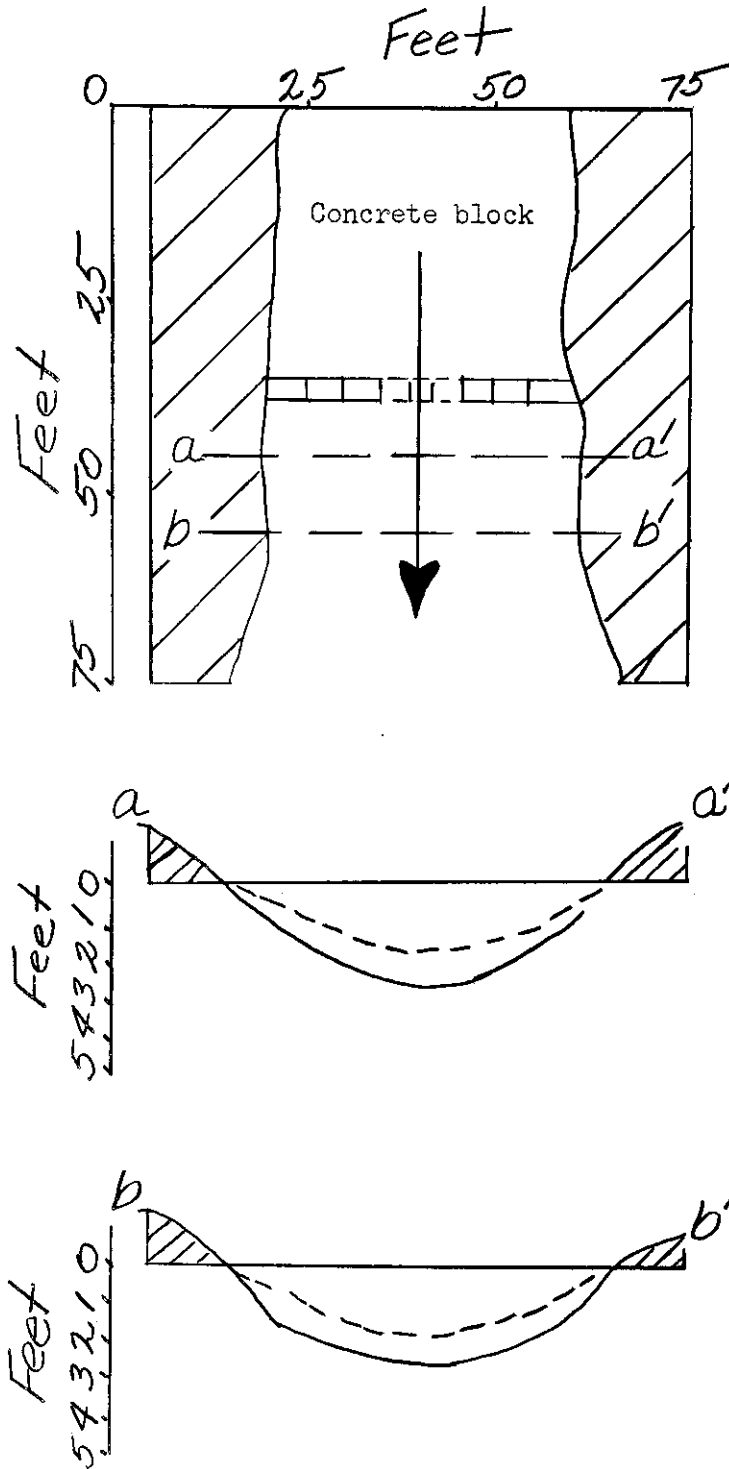
Figure 8. Loving Creek installation #2. Dotted lines show cross-section of stream bottom prior to installation of concrete-block structure in October, 1956. Solid lines show cross-section of stream bottom in November, 1956.

Loving Creek installation #2. A concrete-block structure was installed at this site in October, 1956. By November 1956, the pool below the structure, as a result of digging action, had enlarged and increased in depth from 20 to 29 inches (Figure 8).

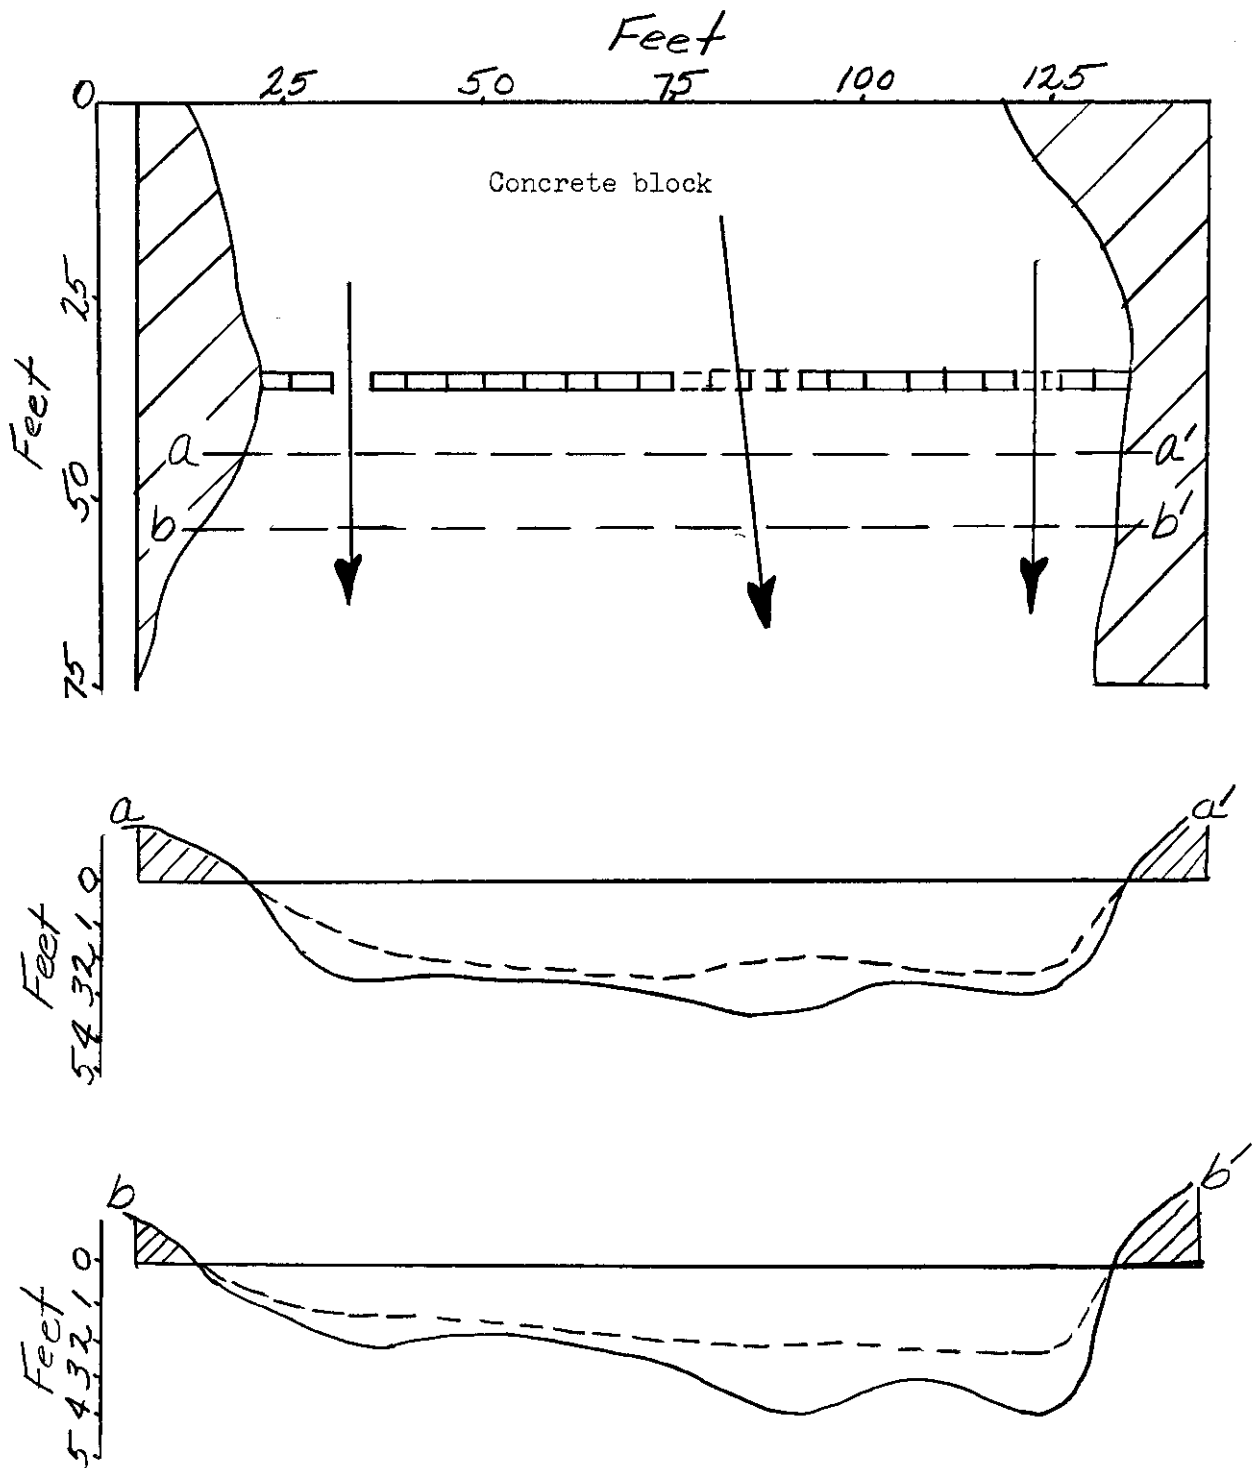
Figure 9. Silver Creek installation #1. Dotted lines show cross-section of stream bottom prior to installation of concrete-block structure in October, 1955. Solid lines show cross-section of stream bottom in November, 1956.

Silver Creek installation #1. The concrete-block structure installed in October, 1955 at this site is 120 feet in length. Initially, this structure was one base block and two common blocks in height except for the three openings which were one base block and one common block high (Plate 6). By May, 1955, a hole had washed under the base blocks at the opening on the south side. The common and base blocks at this opening were removed. The common blocks were removed at the other two openings and the height of the structure, except at the openings, was increased to one base block and three common blocks. By November, 1956, the pools below the south, middle and north openings in the structure, as a result of a raise in water levels plus digging action, had enlarged and increased in depth from 18 to 30 inches, 28 to 47 inches and 25 to 48 inches, respectively (Plate 7 and Figure 9).

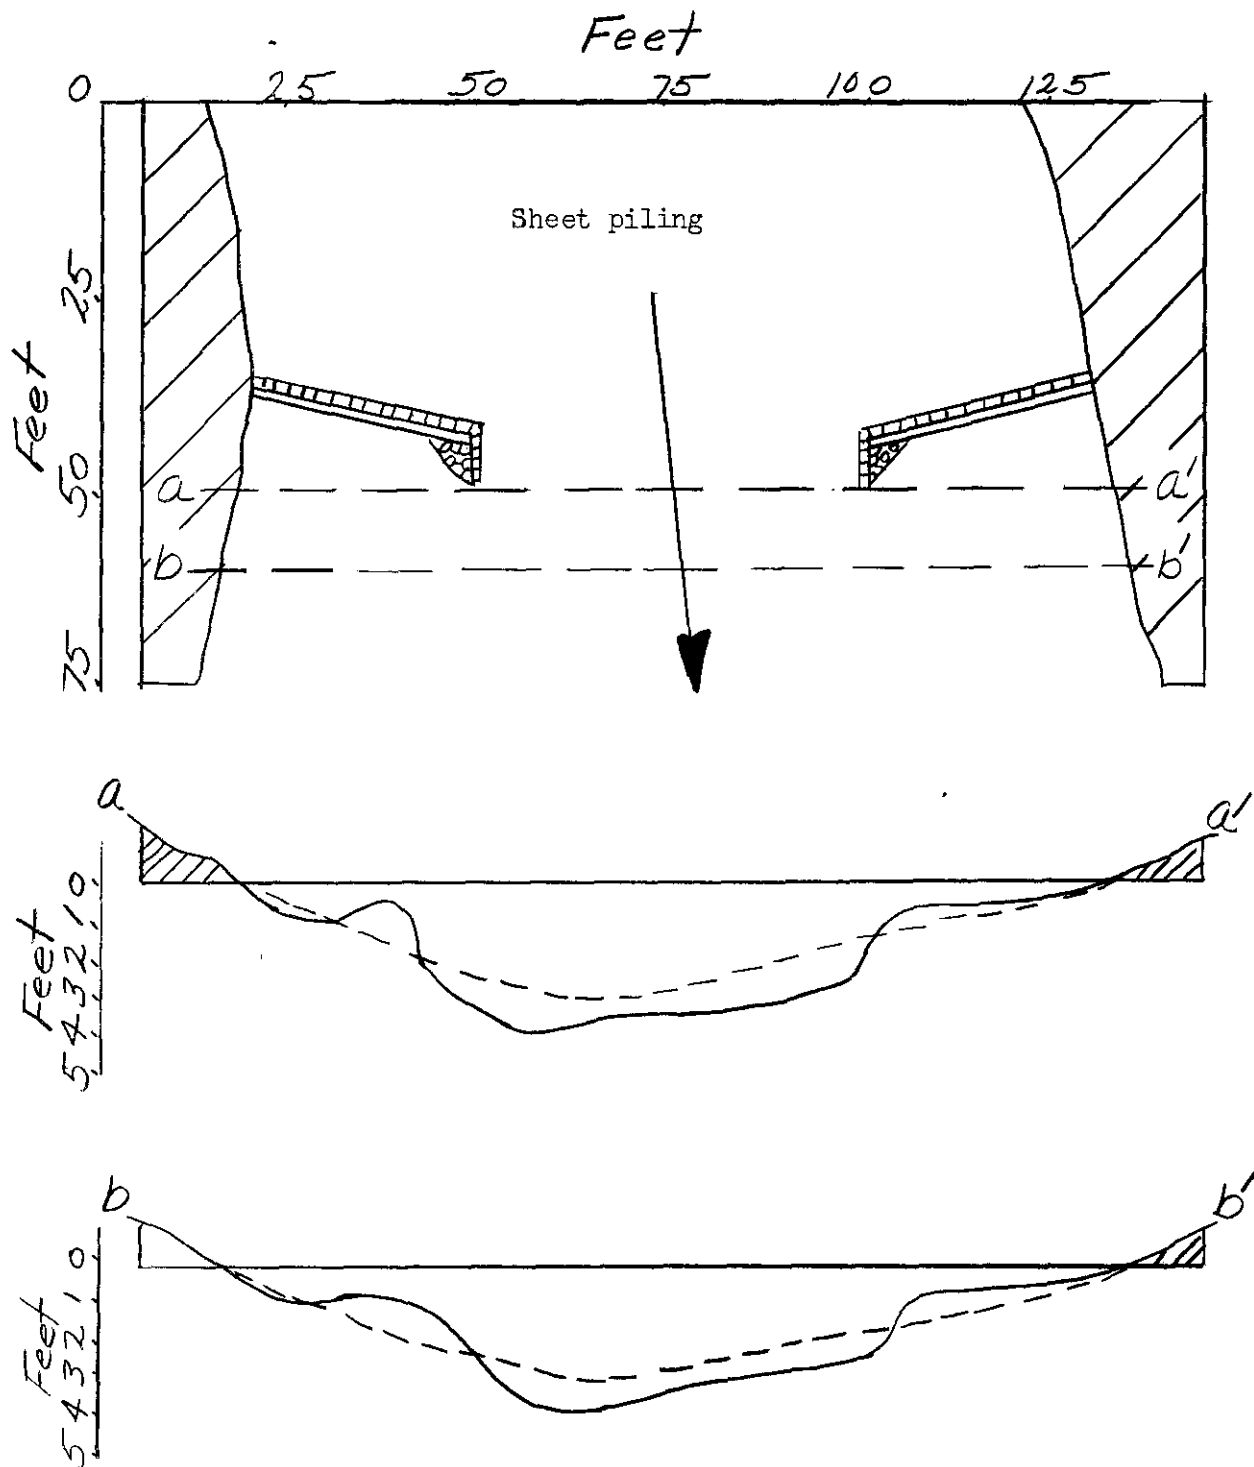
Figure 10. Silver Creek installation #2. Dotted lines show cross-section of stream bottom prior to installation of sheet piling structure in November, 1955. Solid lines show cross-section of stream bottom in September, 1956.

Silver Creek installation #2. A sheet-piling structure was installed at this site in November, 1955. During December, 1955, surface ice formed on Silver Creek in the vicinity of the site causing water levels to raise and flow over the structure. The wing deflector and the outer end of the sheet-piling structure extending from the south shore were forced upward by the ice pressure and an opening was washed under the structure at this point (Plates and 46). No other damage to the structure was noted; but the aquatic vegetation washed from this section of the stream during the early part of the 1956 season. The sheet-piling structure extending from the south shore was repaired and strengthened in June, 1956 (Plate 8).

By September, 1956, the pool below this structure, as a result of digging action, had enlarged and increased in depth from 32 inches to 40 inches (Figure 10).

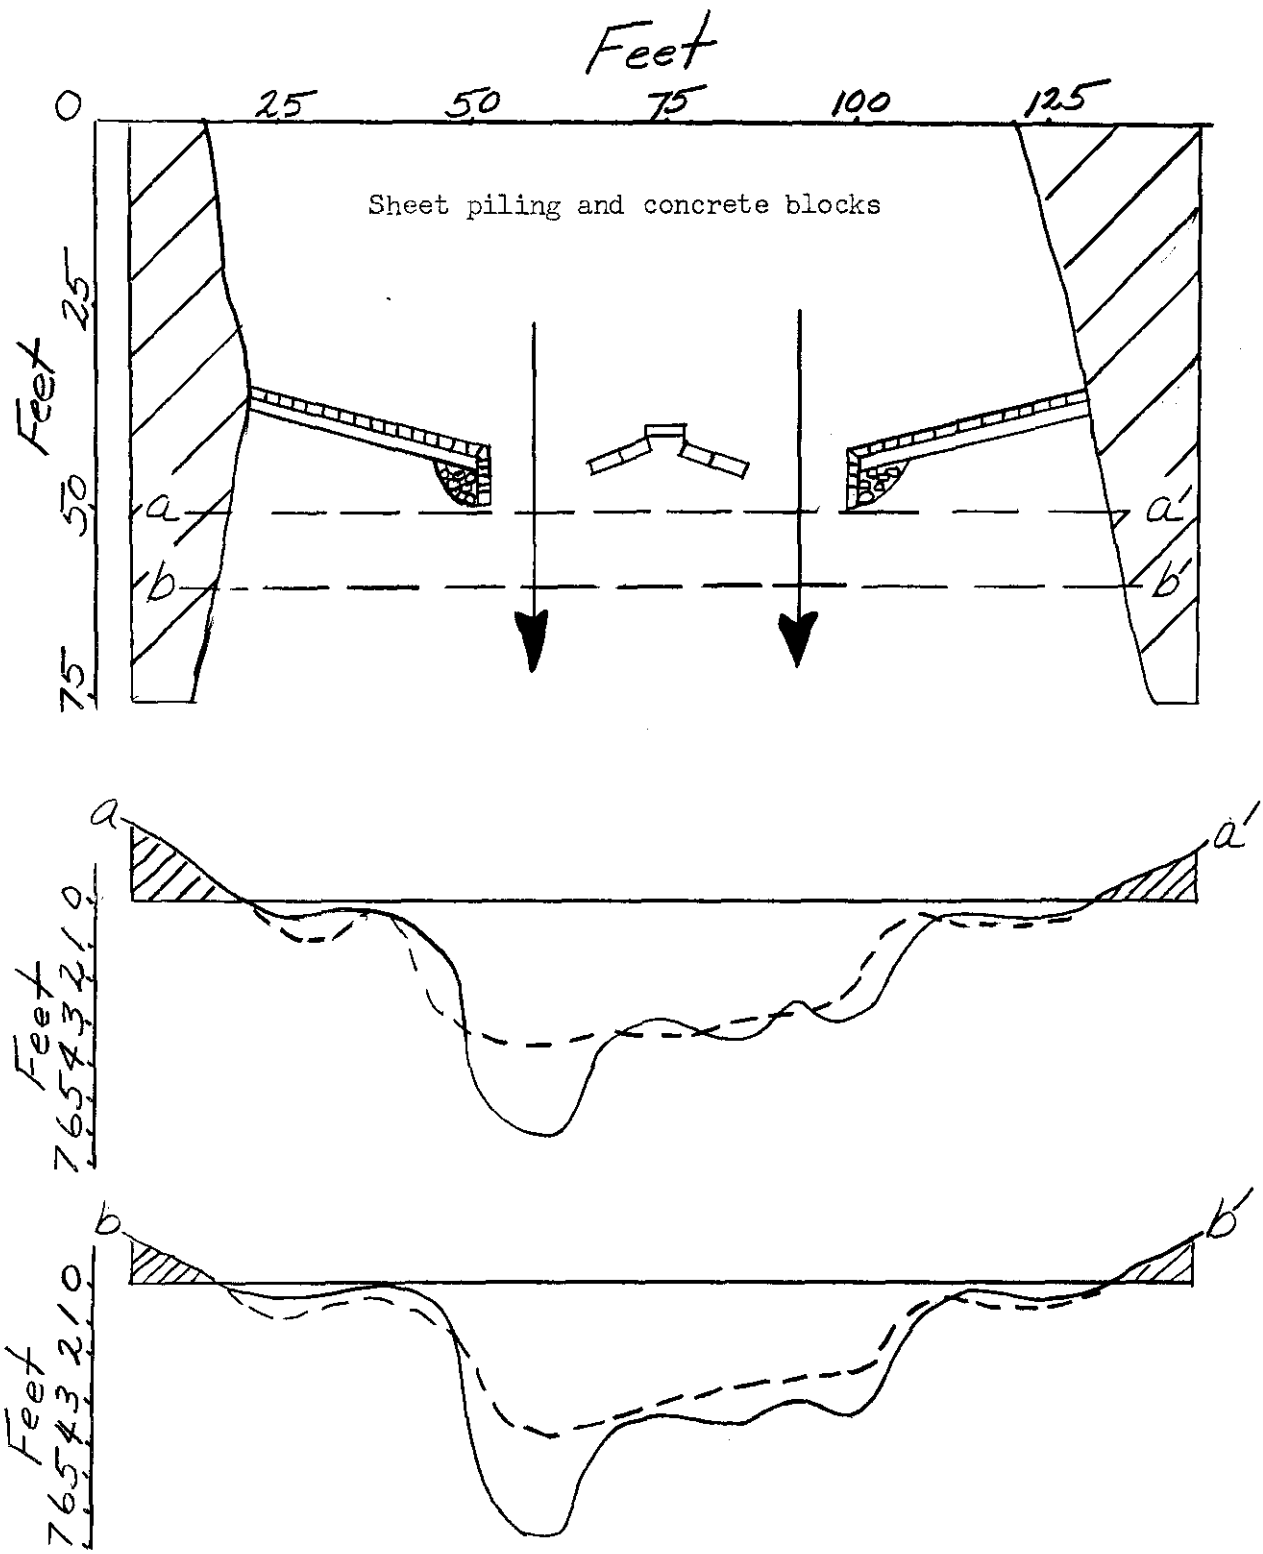
Figure 11. Silver Creek installation #2. Dotted lines show cross-section of stream bottom in September, 1956. Concrete-blocks were added in October, 1956. Solid lines show cross-section of stream bottom in November, 1956.

During October, 1956 five rows of common concrete blocks four blocks high, held in position by iron fence stakes, were installed in the opening between the sheet-piling deflectors. By November, 1956, the pool below the structure, as a result of increased digging action, had increased in depth from the original 32 inches to 78 inches (Figure 11).

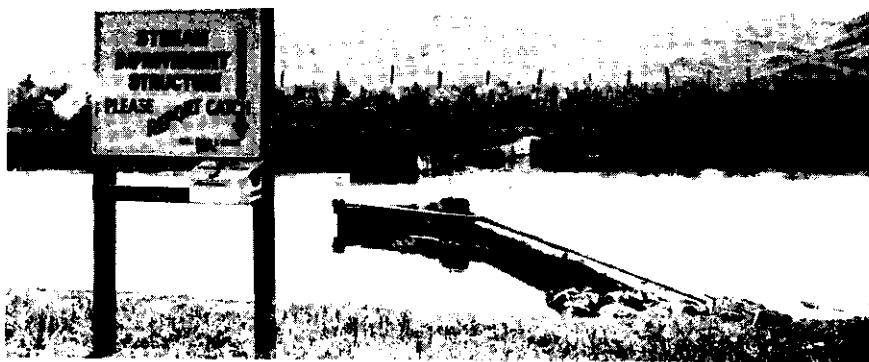
Plate 8. Sheet piling structure at Silver Creek #2,
July, 1956.
