STATE OF IDAHO
FISH AND GAME DEPARTMENT

Annual Progress Report

EVALUATION OF TRANSPLANTING MID-SNAKE
SPRING CHINOOK SALMON TO RAPID RIVER HATCHERY

October, 1966

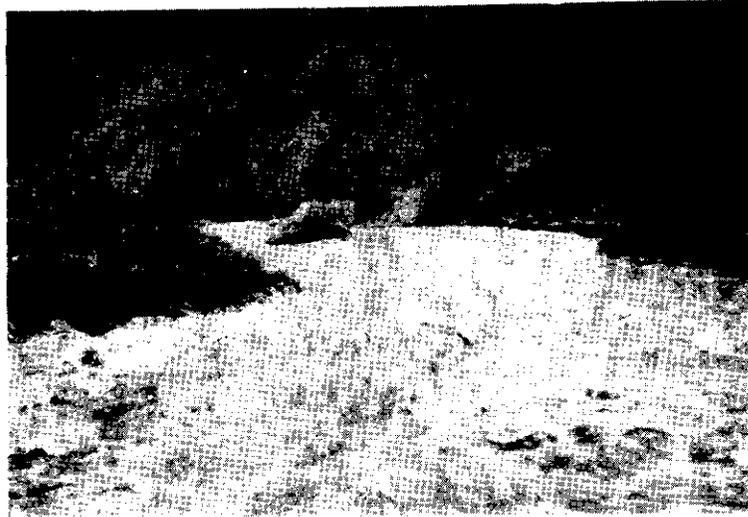
Figure 10. Rapid River during flood, June, 1965. Approximately 1,065 cfs.

Extreme flooding in June of 1965 caused severe damage at the hatchery and evaluation facilities (Figures 10-15). Approximately 100,000 salmon fingerlings were lost during this period. Observation of these fish indicate they were mostly substandard scrubs and pinheads that were weak fish and not capable of withstanding the high turbidity of the water. Experience indicates that these fish would most likely have been lost to natural mortalities in event the flood had not occurred.

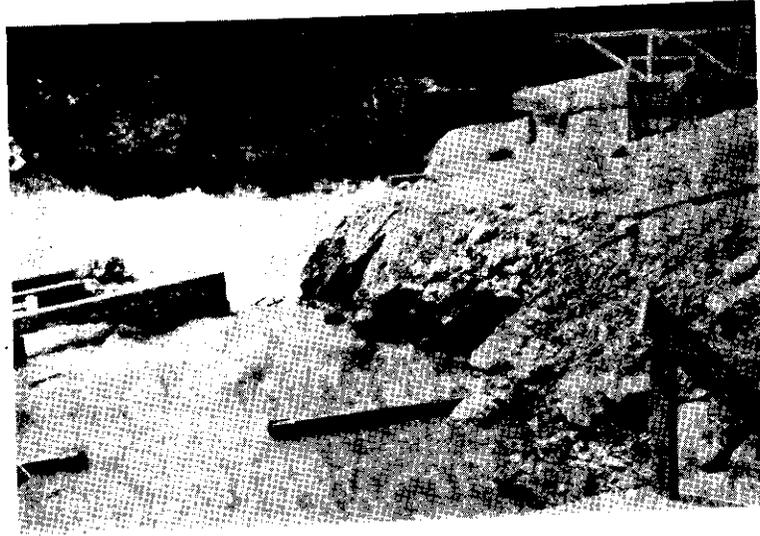
Figure 12. Right side of bypass channel entrance was washed out by extreme flow of Rapid River. June, 1965.
